Damage Detection Using Destructive Testing of a Reinforced Concrete Slab

DAMAGE DETECTION USING DESTRUCTIVE TESTING OF
A REINFORCED CONCRETE SLAB

A Thesis
presented in partial fulfillment of requirements
for the degree of Master of Science
in the Department of Civil Engineering
The University of Mississippi

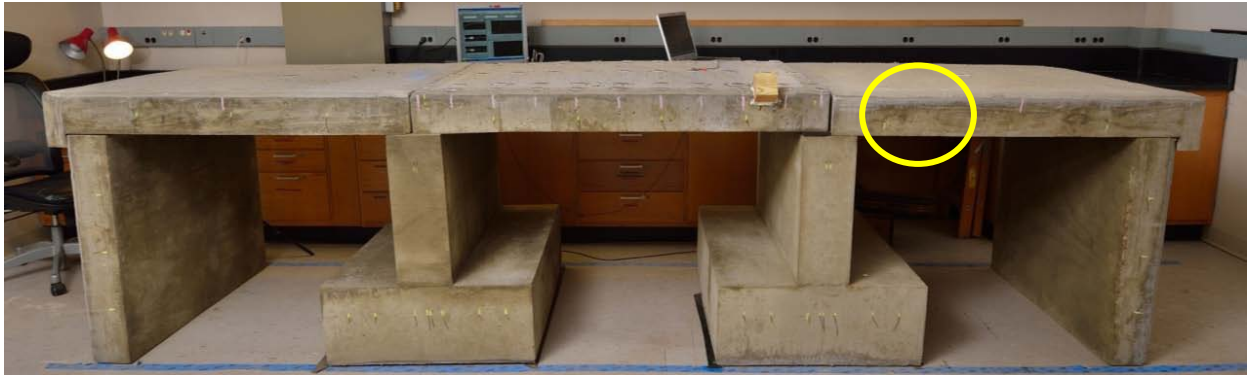
Figure 2-1 Experimental Set-up (2014 Study, Located in the NCPA)

five of these pads were poured on the center test slab. A single pad was poured in the center of each side slab. The pads served as connection points to the bridge for a single tri-axial accelerometer to be attached during testing. Figure 2-1 shows the finished product installed in the National Center for Physical Acoustics (NCPA) [22].

Prior experiments focused on nondestructive changes in the global boundary conditions of the central slab. Eight cases were presented with various objectives: one of which is shown in the yellow circle in Figure 2-1. He achieved this result by applying a sheet of changeable strips that included rubber pads of varying thicknesses and hardness. The first case examined was considered the as-built baseline which was also considered the control case for the experimental series. Being the control, the baseline consisted of the bridge exactly how it was first assembled with no additions or changes made to any of its supports.

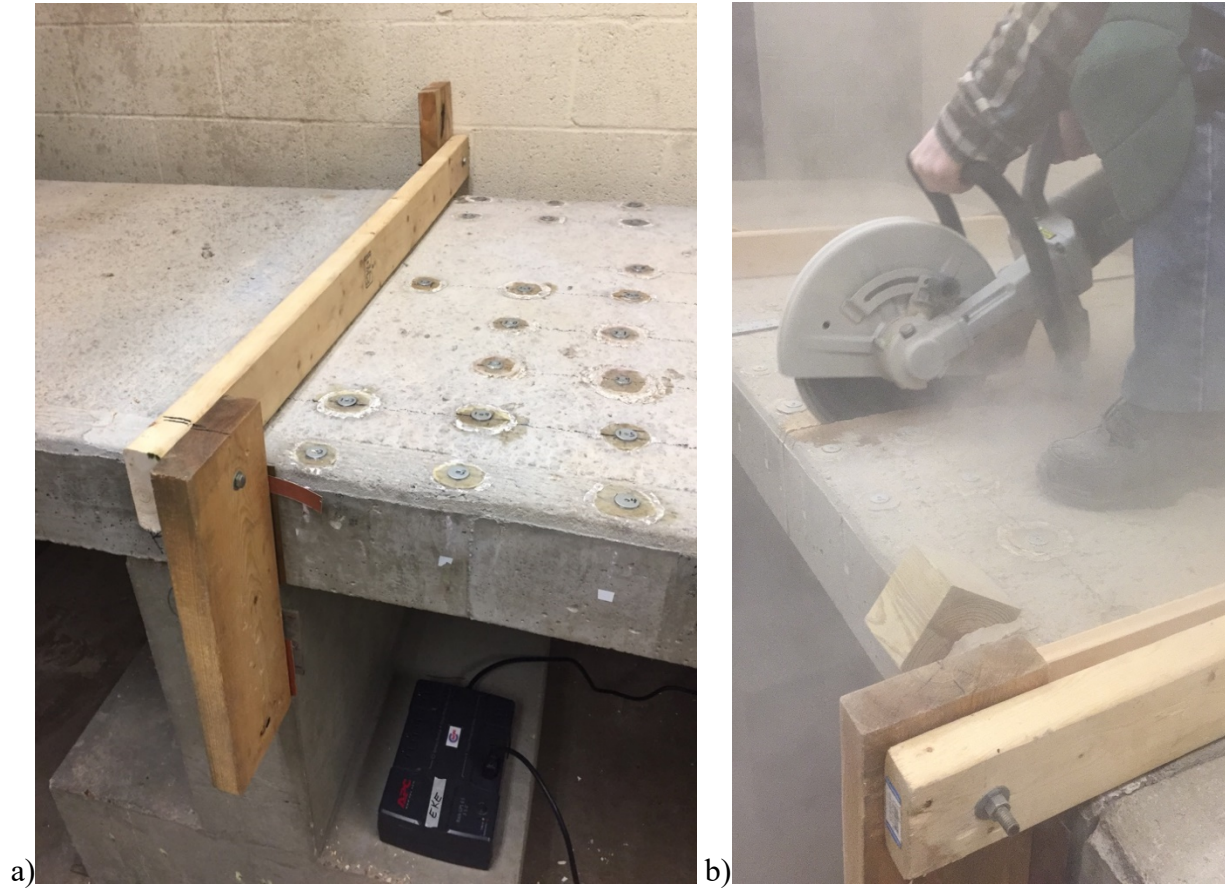
Figure 3-1 Crack Induction
a) Bracing/Clamp
b) Concrete Saw Cutting

Before each cut, precautionary measures were taken. Intense vibrations from the concrete saw might shift the center test slab. Worley’s experiment proved that the boundary conditions have a very significant impact on mode shapes and therefore damage detection [22]. In order to prevent moving of the slab during cutting a custom wooden “clamp” was constructed and applied each time a cut was made. Two of the clamps in Figure 3-1a were installed, and then cutting commenced as in Figure 3-1b. Note that no major change was later seen in the data to support that the saw vibration caused any significant frequency shift, except perhaps the baseline.

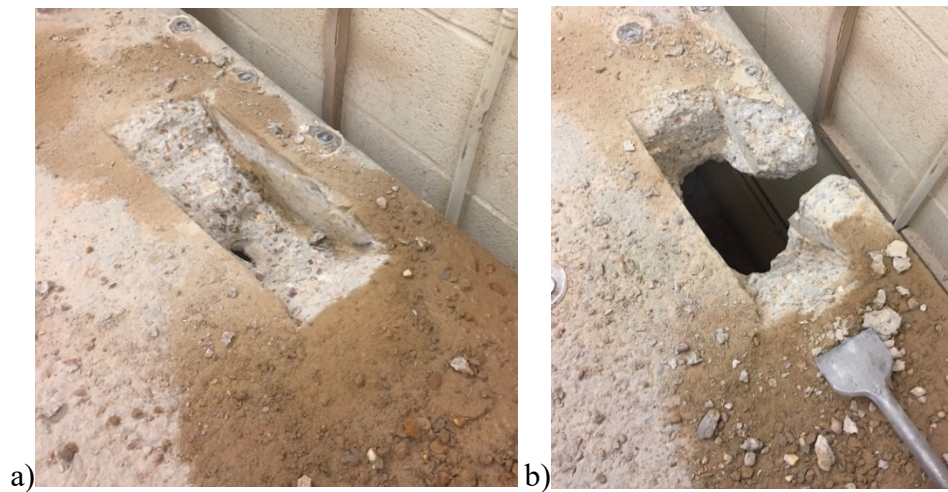
Figure 5-3 Node 58 Demolition

a) Partial Damage
